# Richmond Refinery LPS Bulletin-Reliability

## Alky- K-1420 Trip

(1/31/2012)

**IMPACT ERM**  
**Loss ID# 30674**

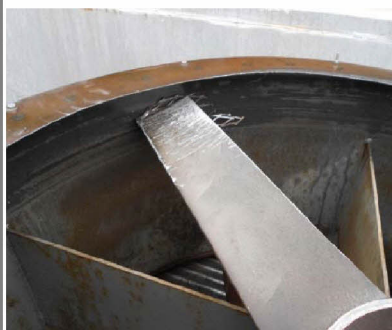
Screen material bound up between the fan shroud and fan blades.

On January 31, 2012, the Alky unit was shutdown for less than a day after the refrigerant compressor, K-1420, tripped offline due to loss of cooling system pressure to the Variable Speed Drive (VSD). Operators quickly found that the thyristor cooling system fan shroud protection screen had fell into the rotating fan blades below where the screen material had punctured several of the finned cooling tubes below the fan blades. The punctured tubes were the cause of the loss of cooling system pressure. Appropriate personnel were contacted to make the needed repairs to the cooling system and fan shroud, and then the Alky unit was restarted without incident.

- 1) Reinforce with maintenance planners, shops and zone mechanics the need to involve engineering and operations in design changes and the need to utilize the MOC process in these decisions.
- 2) Purchase and install the original screen design from fan manufacturer on K-1420 thyristor cooling system fan.

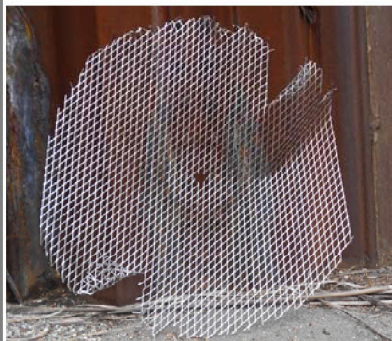
Remains of expanded metal screen after failure.

- 1) A new screen had been fabricated and installed for the fan shroud in November 2011 during routine motor replacement for the fan.
- 2) The new screen was of a different design than the original screen.
  - 1) The materials of construction had been changed.
  - 2) The installed elevation was lower than original design thereby reducing the space between the screen and the motor.
  - 3) The installation method was changed to a welded connection below the shroud rim rather than a bolted connection to the top of shroud rim as was previously used.
- 3) No MOC was initiated to properly address the design changes to the fan shroud protection screen. Engineering had not been involved in the change of this screen.
